Inspector's Daily Report

IDR Sheet	1	of	1	Sheets	Final Record Book	Page
Contract	C-7852			Day	Monday	
				Date	October 25, 2010

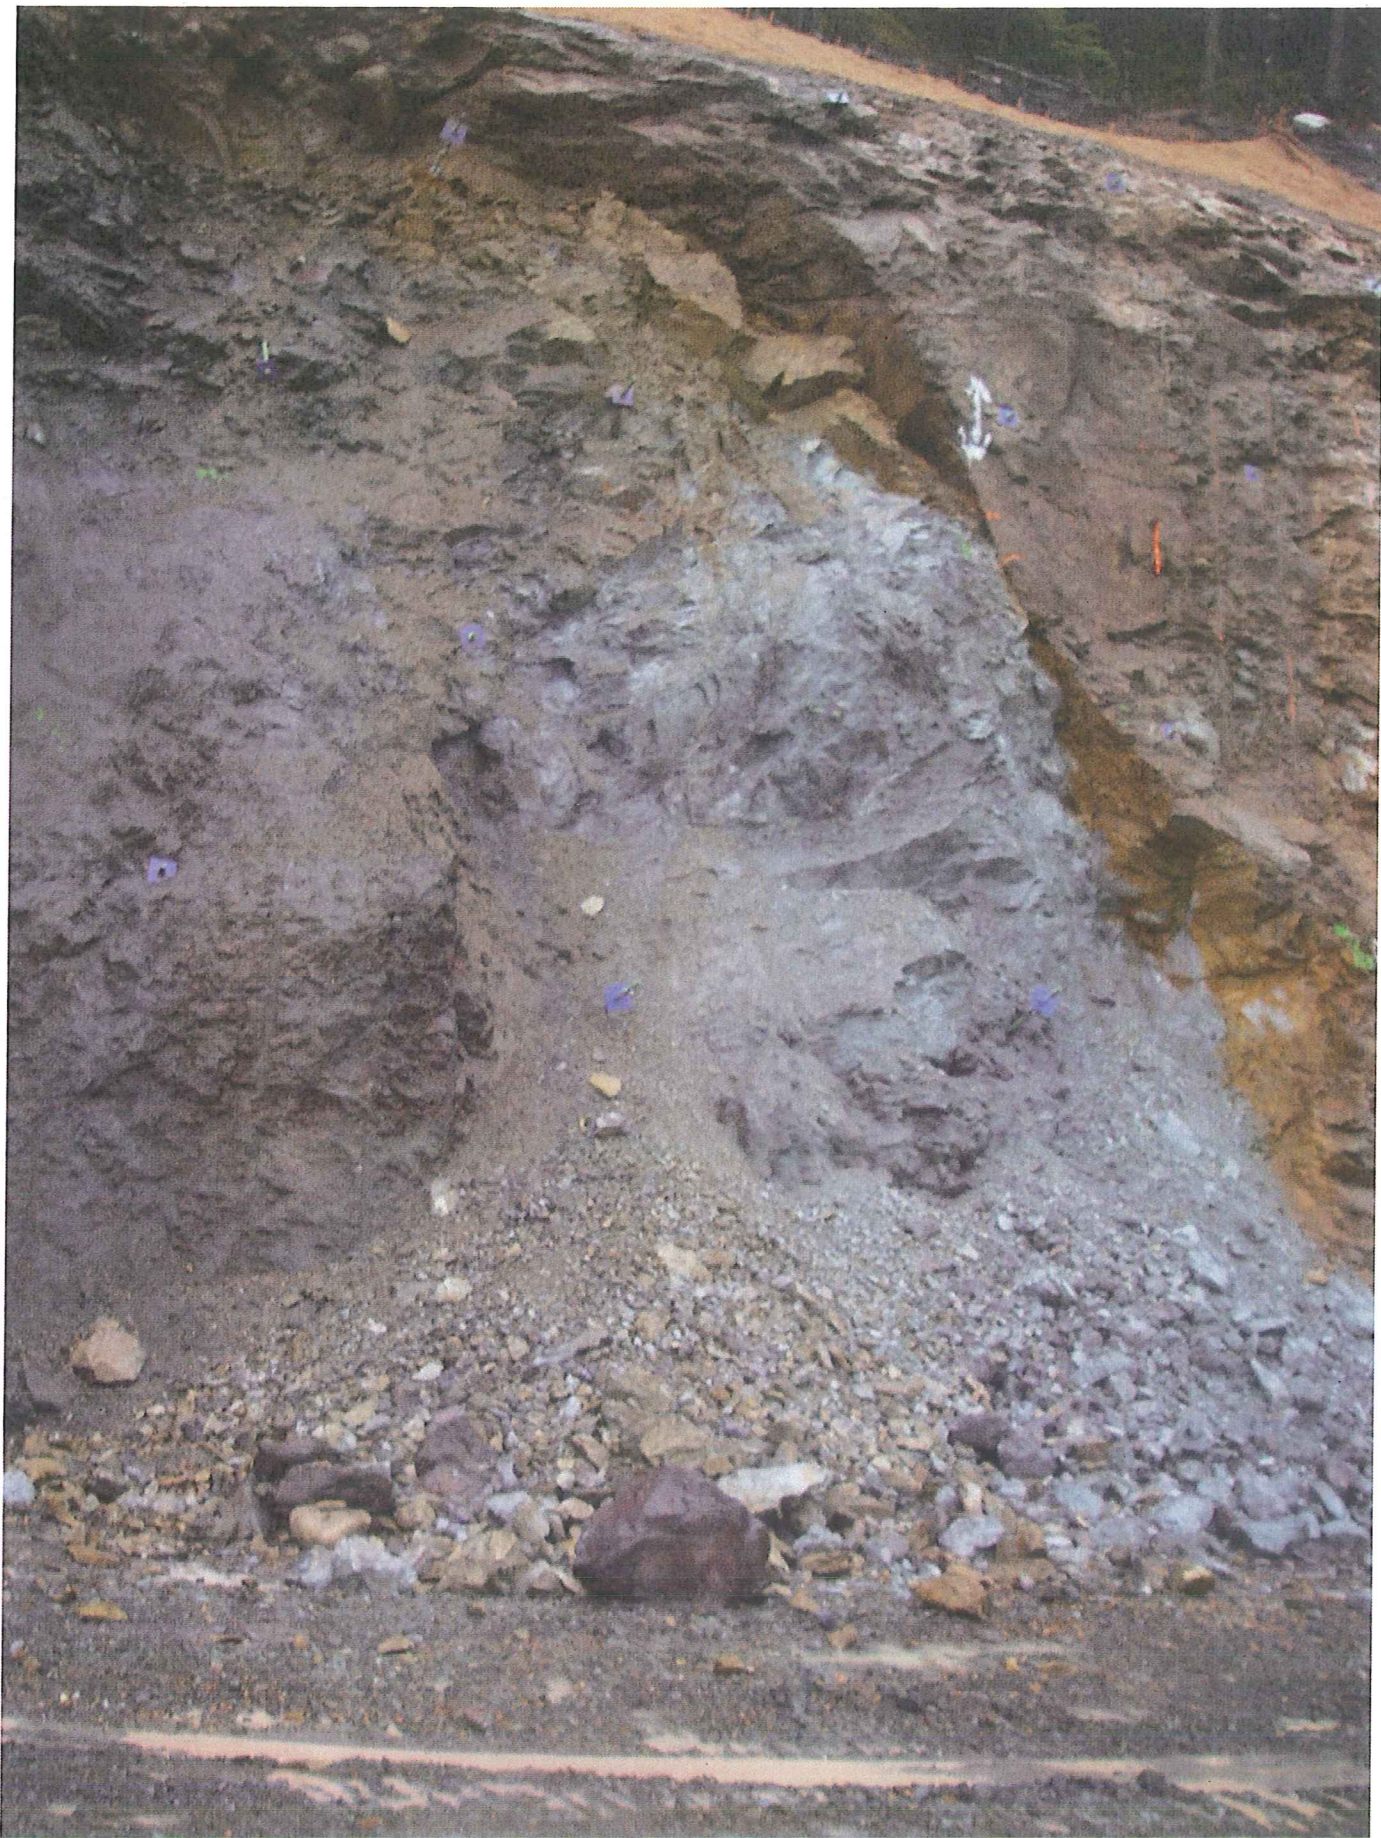
I arrived on the west end of the project to meet Brad Schut (WSDOT Inspector) about a recent rock failure at approximate station 1325+00 (Figure 1). According to Brad, approximately 15 to 20 cubic yards of material failed over the weekend from the same area as the previous couple of weeks. The tension crack that was observed months ago appears to be opening wider where the failure is occurring (Figure 1). The crack appears to be anywhere from 1 to 6 inches wide. According to Norm Norrish, there are prisms located on either side of the failed section with nominal to no measured movement, indicating that this is a localized failure (Figure 2). While I was taking a series of photographs, the slope continued to produce raveling type failures, indicating that the slope is marginally stable in this location.

While Brad and I were conducting the lift inspection, he received a call that the recent rockfall location at station 1325+00 produced more rockfall. Brad, Rocki Bishop and I drove to the west end of the project to assess the slope at station 1325+00. It appears that a few 2 to 3 foot rock blocks, toward the top of the slope failed, producing an additional 4 to 5 cubic yards of debris (Figure 2). I took a series of photographs and drove to the Hyak office to download the photographs and start my IDR.

Figure 1. A photograph showing the active rockfall location at approximate station 1325+00.

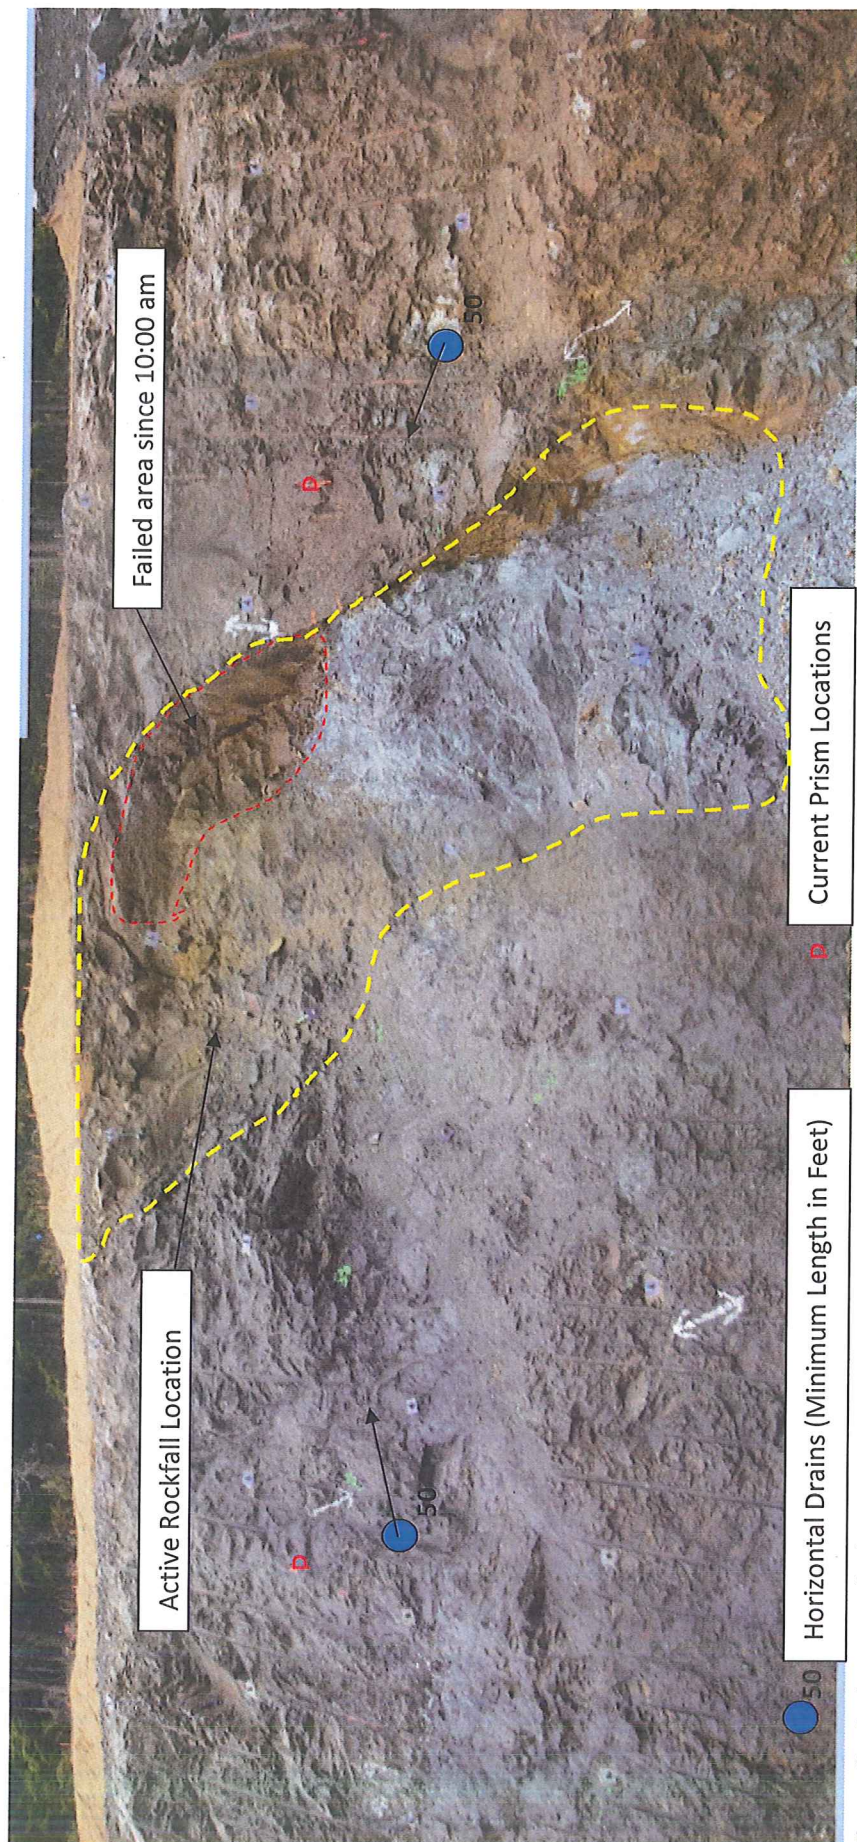
Figure 2. A photograph showing the recent failure location around station 1325+00. The horizontal drains should be directed towards the active failure location. Note that the prisms on either side of the recent failure location show nominal to no movement.

I drove to the Hyak office to download the photographs, send them to the Regional and Geotechnical Division offices, and discuss the slope with Will Smith, Norm Norrish and Tom Badger. I indicated that the slope appeared to be marginally stable and the raveling failures continue. We all came to the decision that it is too dangerous to have the contractor install the shotcrete application at this time and work should focus on the other areas detailed in Mike Mulhern's 8/31/2010 IDR and Norm Norrish's construction memorandum dated 9/27/2010. Norm also indicated that he would like the contractor to install two horizontal drains on either side of the failing area and direct them towards the failed location in an attempt to reduce any water pressure that may be present. These drains should be installed in the more competent bedrock, outside the failed location, as shown in Figure 2.

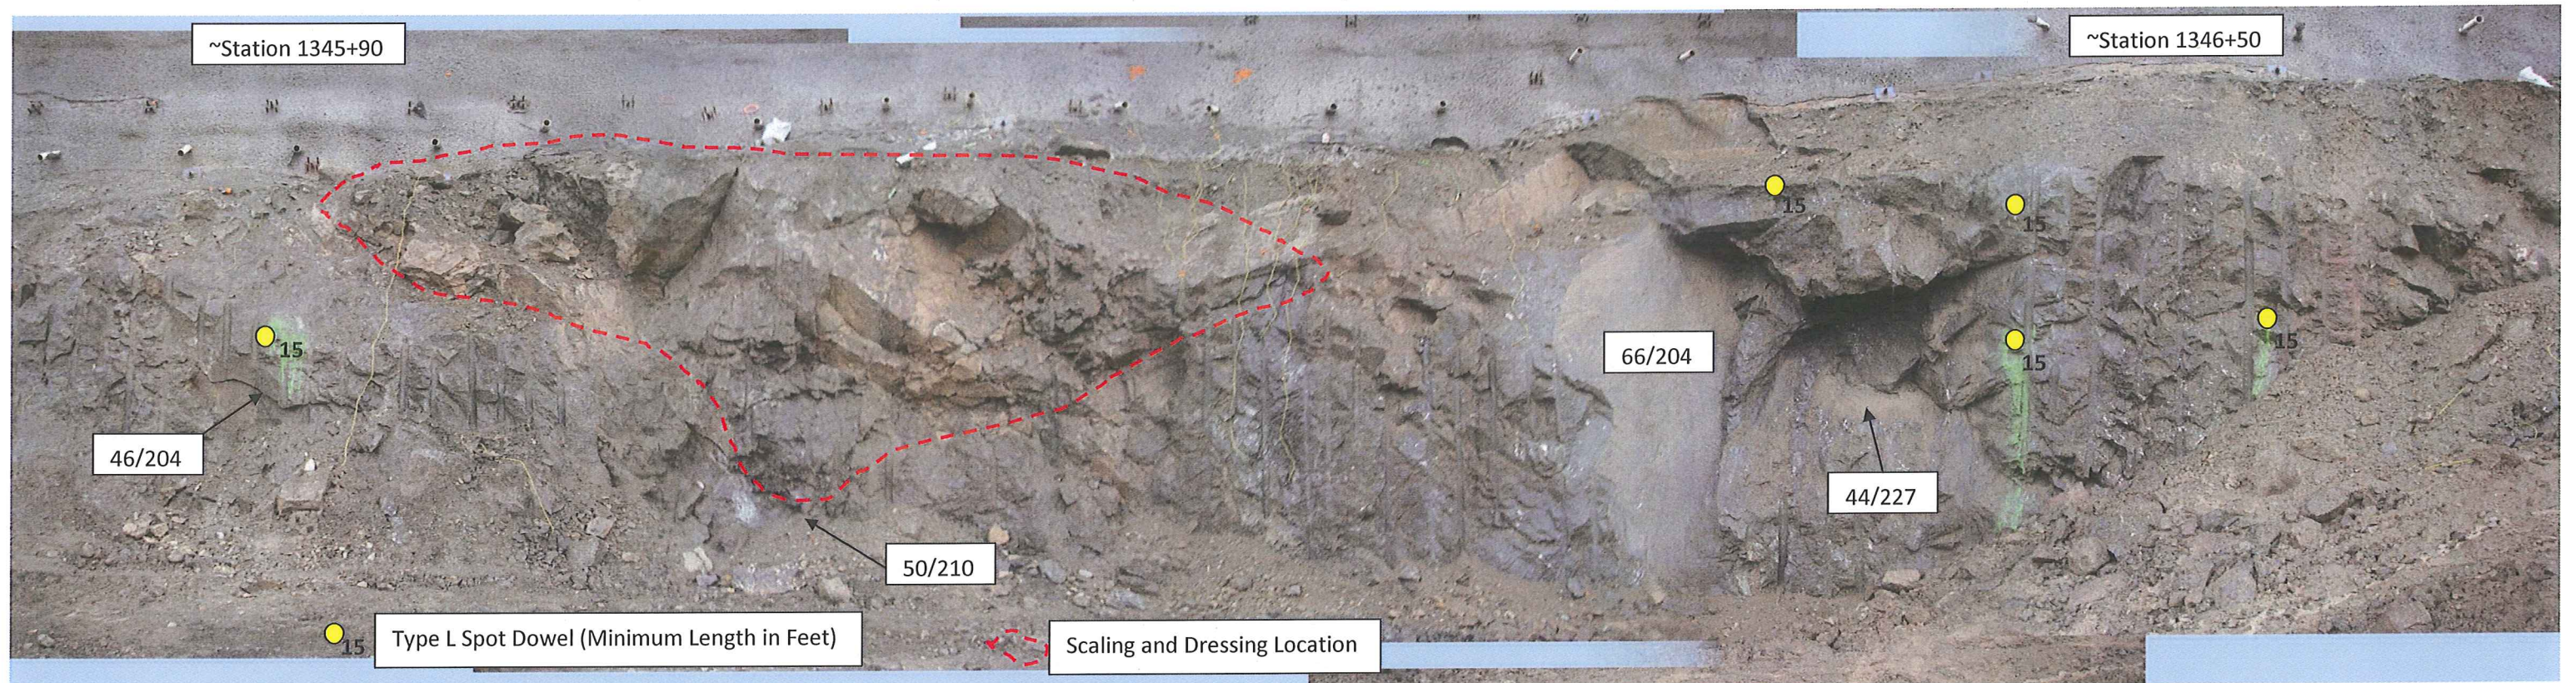
Brad and I drove to the east side of the project to conduct a lift inspection from approximate station 1345+90 to 1346+50. We located five Type L spot dowels and an area that needed additional scaling and dressing (Figure 3). Additional spot dowels may need to be located in any adverse structure or unstable rock blocks that might be exposed following scaling and dressing operations.

Figure 3. A photograph of the lift inspection from approximate station 1345+90 to 1346+50. Additional dowels may be located once all the scaling and dressing is completed.
